**Contract Administrator's Instruction**

**Ref:** CAI-009

**Proposed Works:** Temporary Propping at All Saints Church, Mackworth

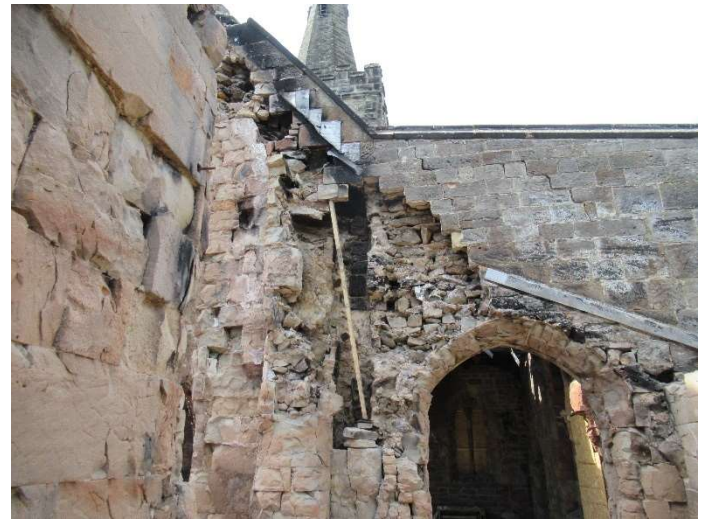
Existing timber prop

The area of stonework to the wall between the vestry and the north aisle is significantly damaged and potentially unsafe. During a site visit on 15<sup>th</sup> April 2021, Buildzone were instructed to remove some of the unsafe stonework which left some of the higher-level stonework unsupported. A timber prop was installed as an interim measure. It is proposed to consolidate the low-level stonework with the application of mortar

pointing. New masonry will then be built on top of the stone work to provide a firm, level base for new timber props that will remain in position for the medium term whilst the debris within the vestry is removed. The area will be reviewed in more detail once better access is available.

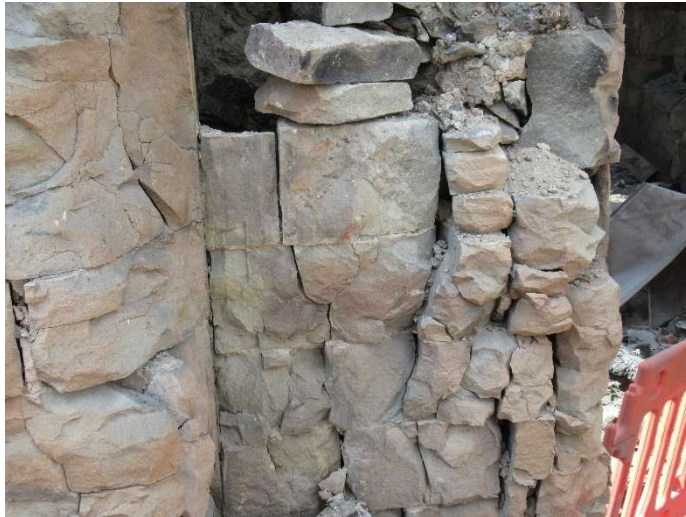
Low level stonework

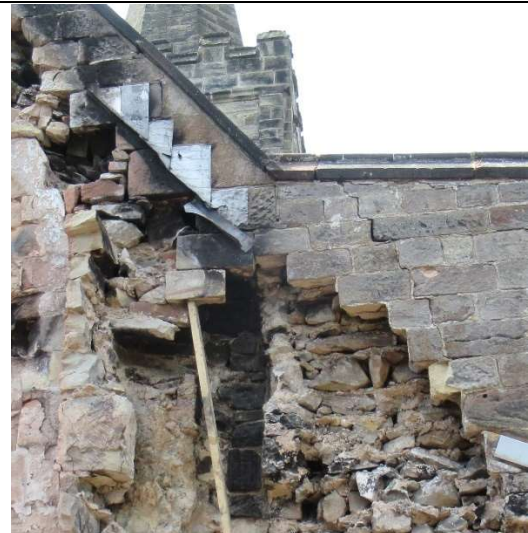
Close up on high-level stone with flue behind

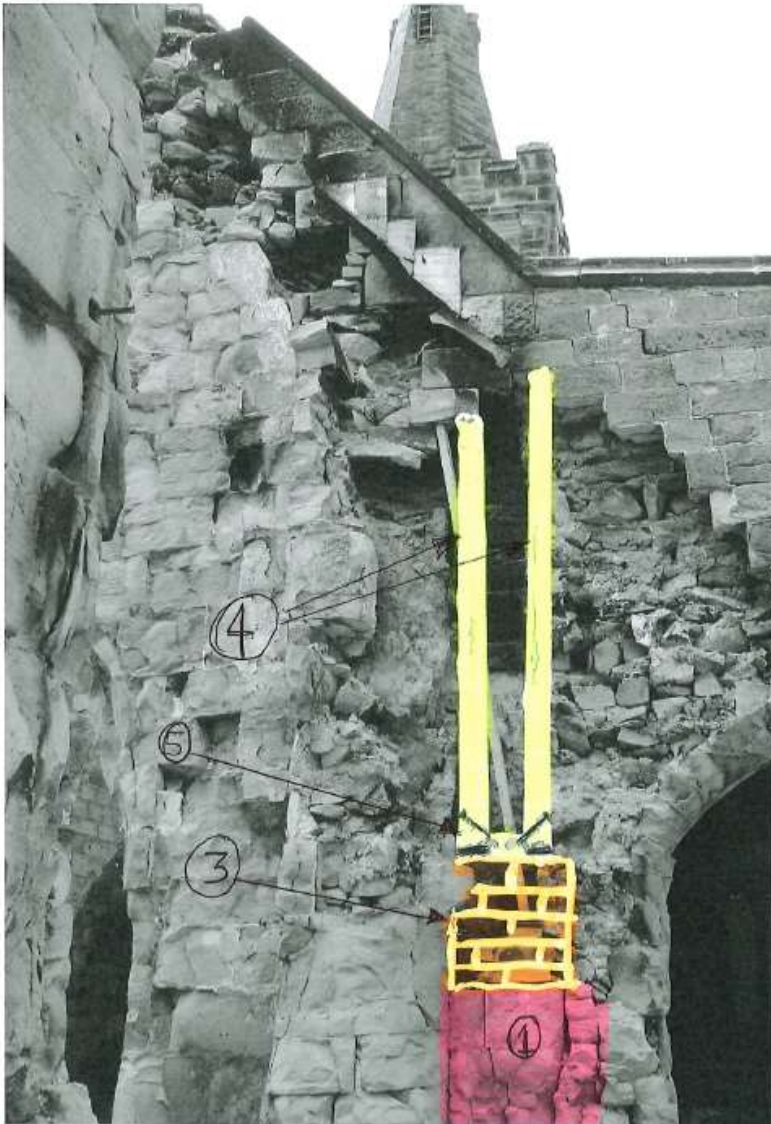
SK107.

PROPPING METHODOLOGY:

1. APPLY MORTAR POINTING TO EXISTING STONEMWORK JOINTS & CRACKS AT LOW LEVEL TO CONSOLIDATE THE BASE
2. INSTALL SECONDARY TEMPORARY PROP TO ALLOW REMOVAL OF EXISTING TIMBER.
3. BUILD UP COURSED BRICK/BLOCK MASONRY IN CLASS (iii) MORTAR TRYING TO BOND INTO EXISTING STONEMWORK WHERE POSSIBLE.
4. CUT NEW 100x100 TIMBERS TO LENGTH, OFFER UP TO UNDERSIDE OF HIGH LEVEL STONE & PACK BASE WITH SLATE SHIMS.
5. FIX BASE OF POSTS TO SUPPORTING BRICKWORK WITH NOGGINS & SCREWS.
